Chebeague Island School

Facility Conditions Study

Stephen Blatt Architects

July 21, 2015

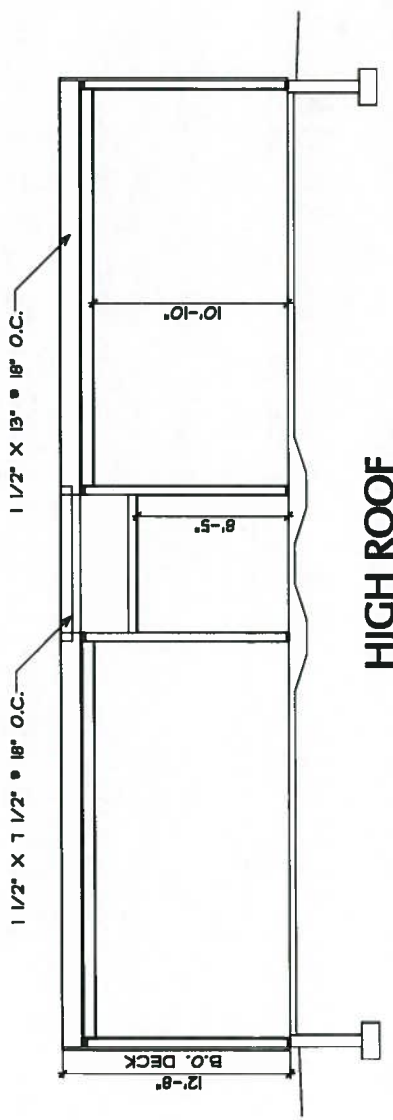
HIGH ROOF

The existing roof joists at the high roof over the classrooms are inadequate for the 23' span.

Cut down the span of the joists by adding beams below the roof joists. The beams would span the length of the classrooms and would bear on posts in the walls between the classrooms. This would require the removal of a strip of ceiling the length of a classroom, adding posts in the walls between rooms, and, more than likely, removing some floor slab to add footings below the floor. It is very unlikely that the existing floor slab would be capable of supporting the post loads. A new soffit would be required in the ceilings under the new beams.
