Chebeague Island Stone Wharf Study Update

January 2022

Jason Gallant, PE
Jason Burns, PE
Jacob Shactman, EIT
Barney Baker, PE (BDC/GEI)

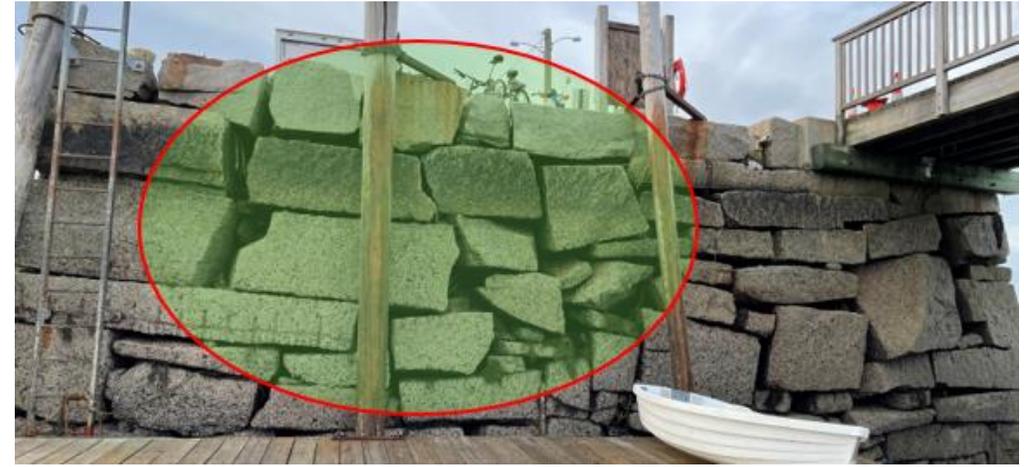
2021 Wright Pierce Inspection Photo

- Conducted a walk-around inspection to note existing conditions.
- Surveyed the Stone Wharf with a 3-D scanning UAV.
- Set survey monitoring points for confirmation over time of movement of the Stone Wharf.
- Compared findings to similar photos taken as part of a 1980 evaluation of the Stone Wharf.

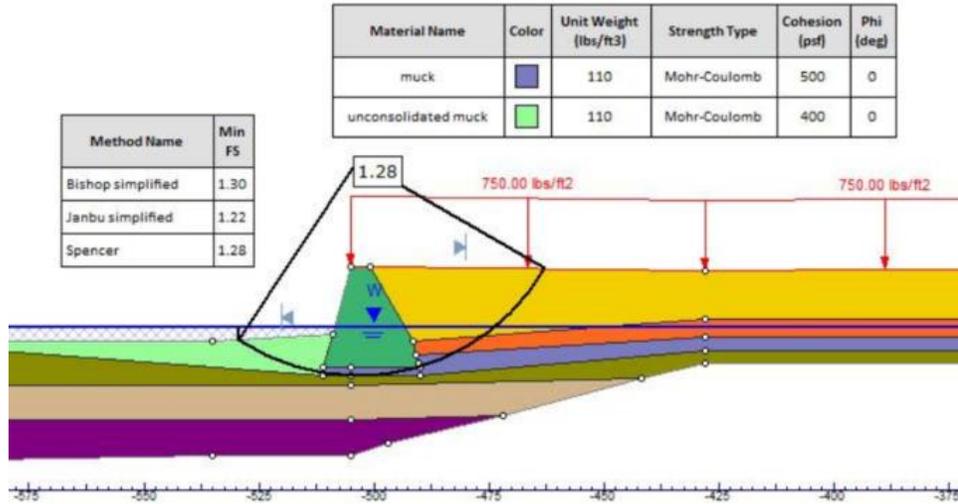
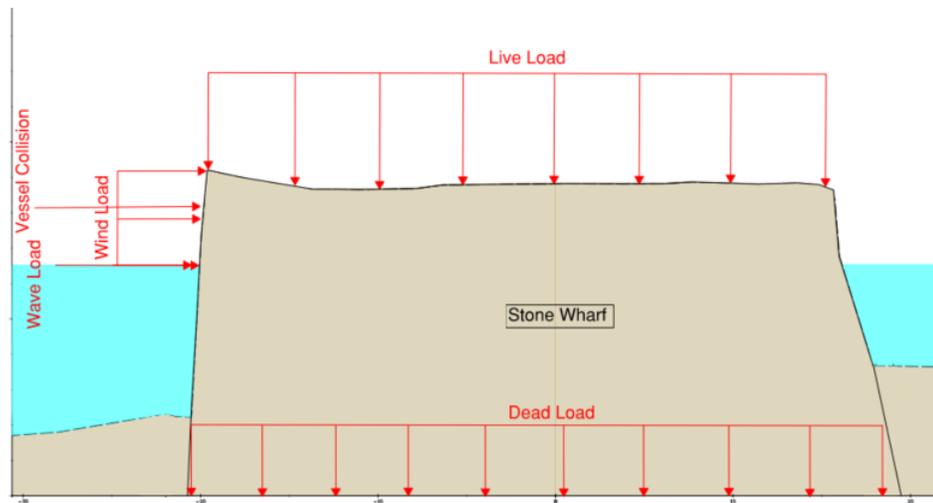
- Conducted a 3-day subsurface program between May 25 and May 27, 2021.
- Subsurface conditions in two of the borings include granular fill over muck on marine sediment and bedrock.
- Timbers were encountered in the upper half of the muck stratum.
- A boring at the head of the pier included muck and marine sediment over Presumpscot Formation of marine silt-clay and a thin layer of glacial till over bedrock.
- Geotechnical and structural stability analyses were completed for existing conditions and a sensitivity analysis was performed for increased Stone Wharf height of 4 and 8 feet in the future to determine if structural strengthening is required.

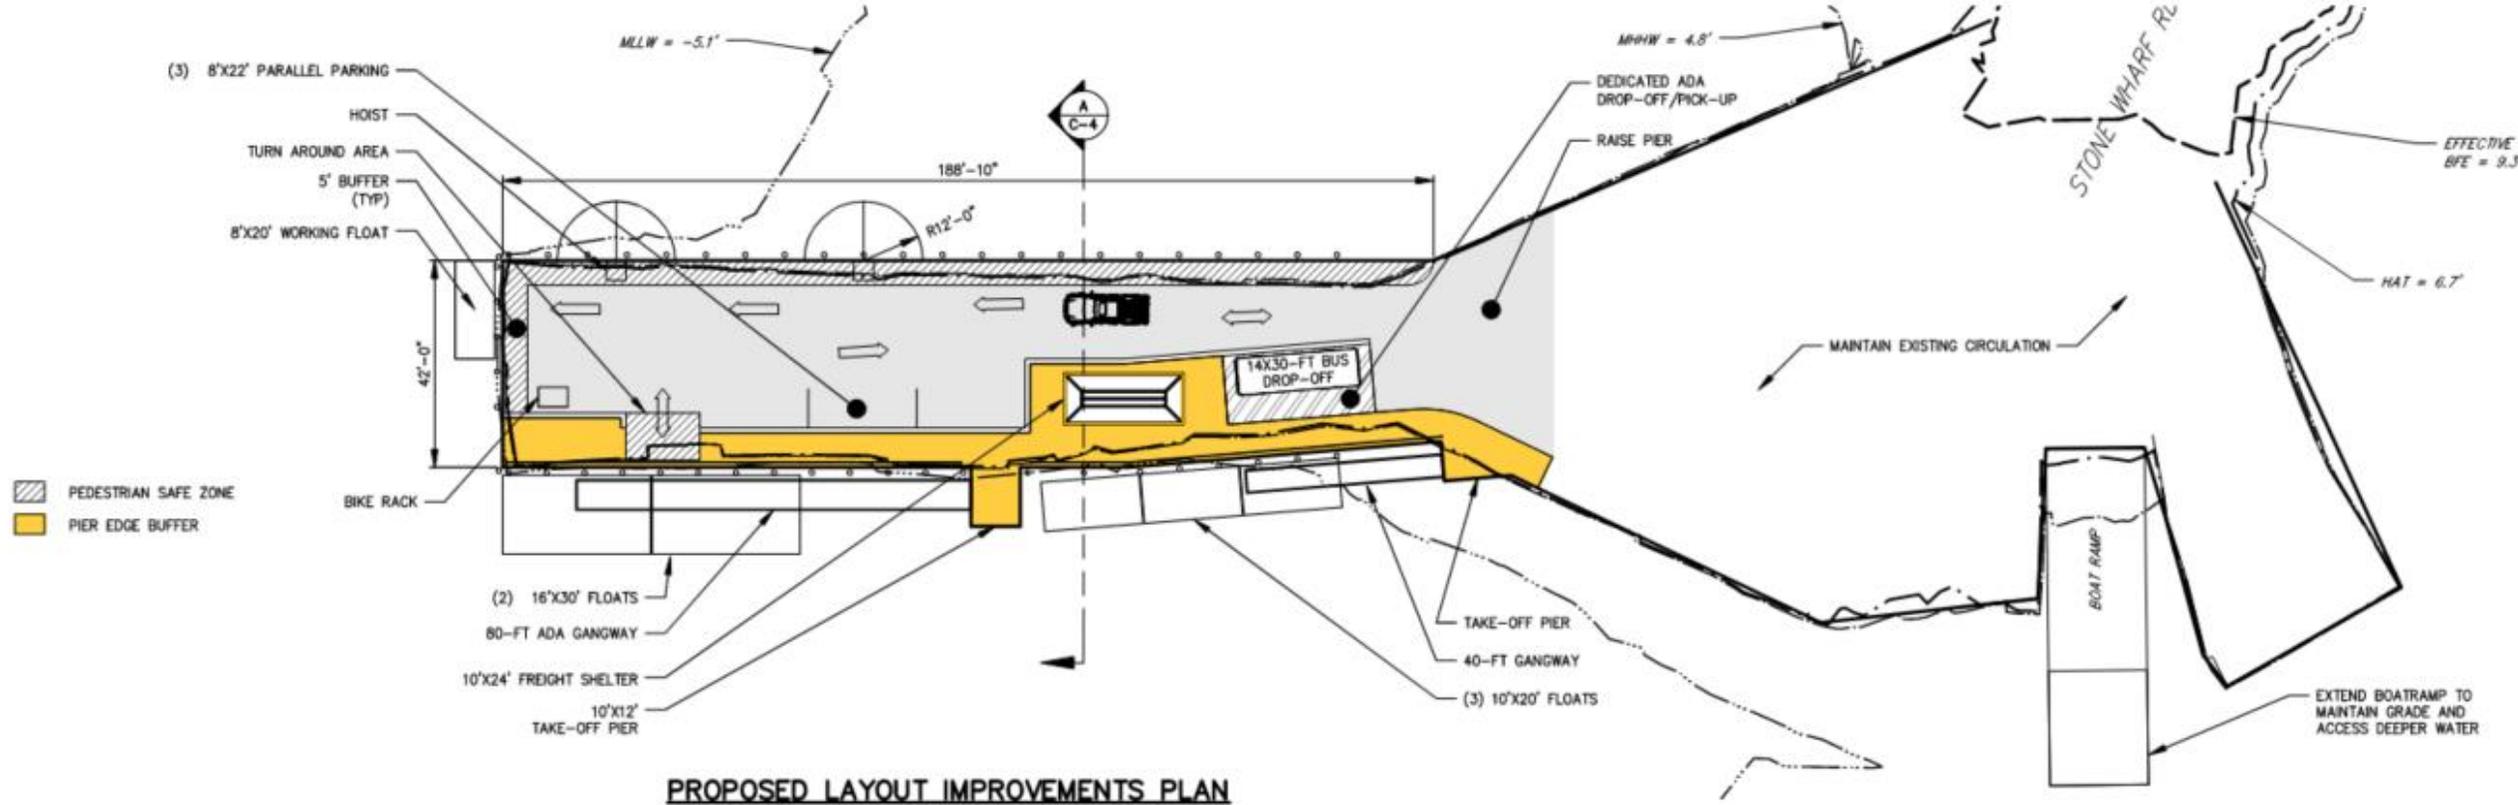
- Proposed revised traffic flow for vehicles and pedestrians.
- Proposed drop-off zone reconfiguration.
- Proposed freight and passenger shelter.
- Proposed reconfigured gangways and floats.

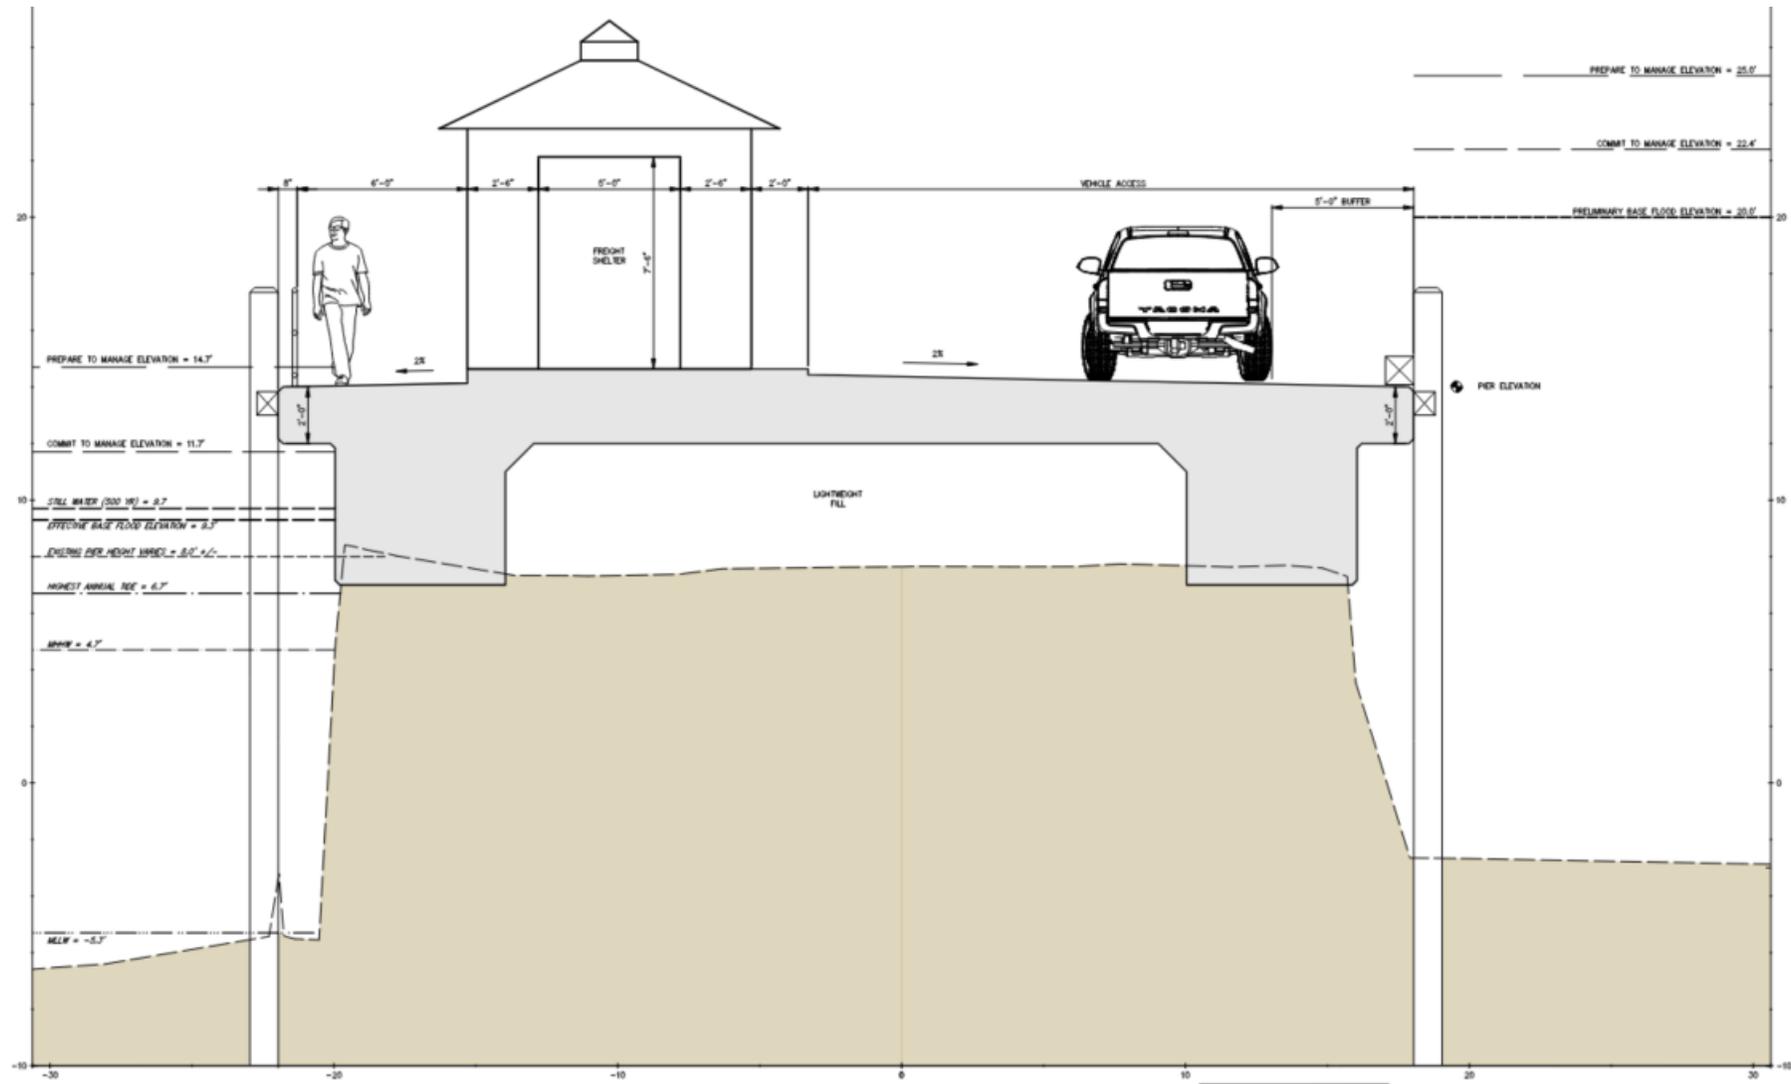
Section A-A Concrete Deck with Lightweight Infill Alternative

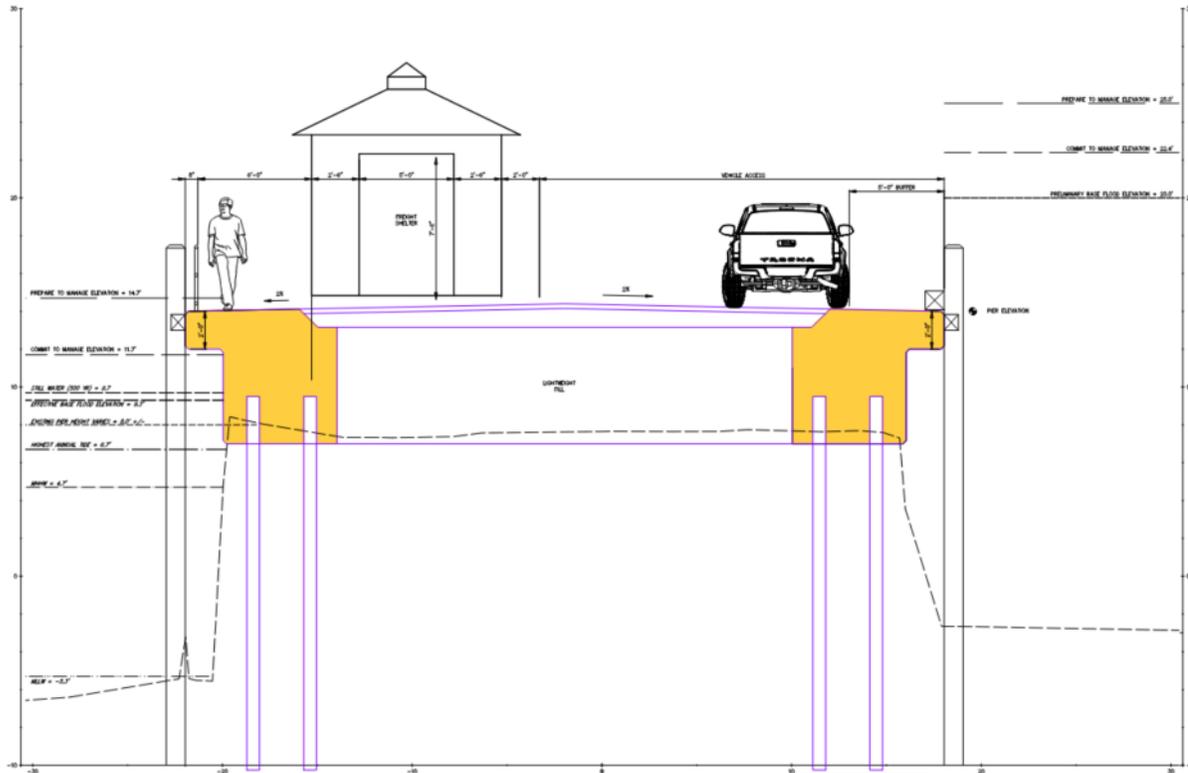
Concrete Grade Beams with Lightweight Infill

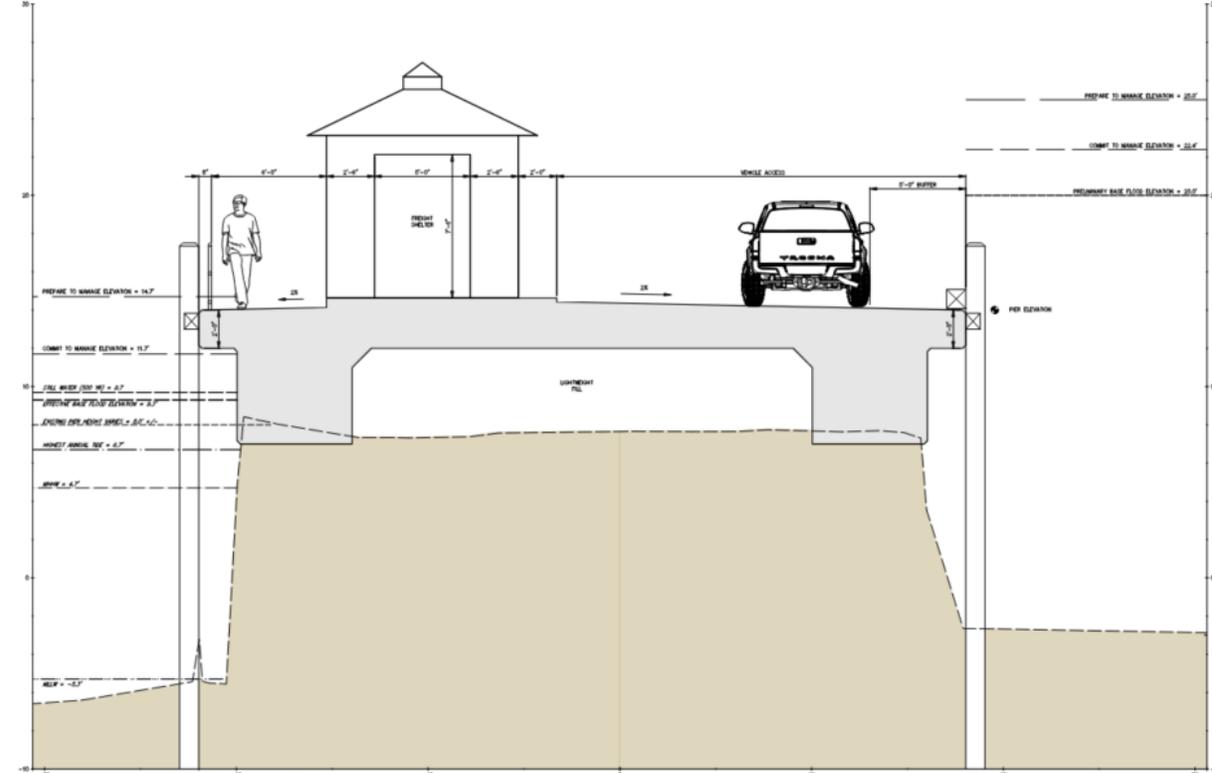
Concrete Deck with Lightweight Infill
